## Management of palatal entrapment of mini-implant supported pendulum appliance: A case report

This case report describes the surgical management of mucosal entrapment of a mini-implant-supported molar distalization appliance.

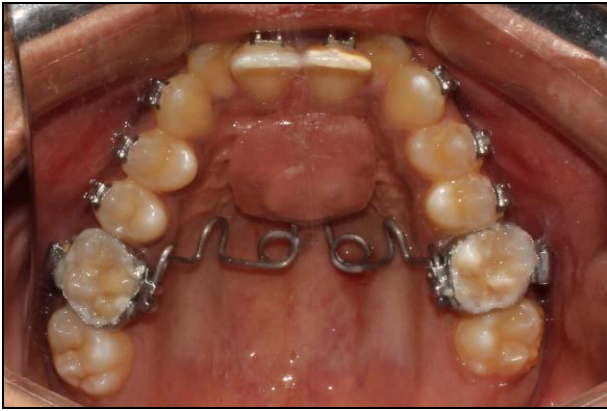
A 17-year-old female patient was referred to Department of periodontics for removal of a mini-implant-supported pendulum appliance entrapped in the palatal mucosa in which is used for molar distalization <sup>[5]</sup> by the Department of Orthodontics. During the patient's fixed orthodontic therapy, the appliance was in place for last eight months (figure 1).

**Fig 1:** Mini-implant-supported pendulum appliance

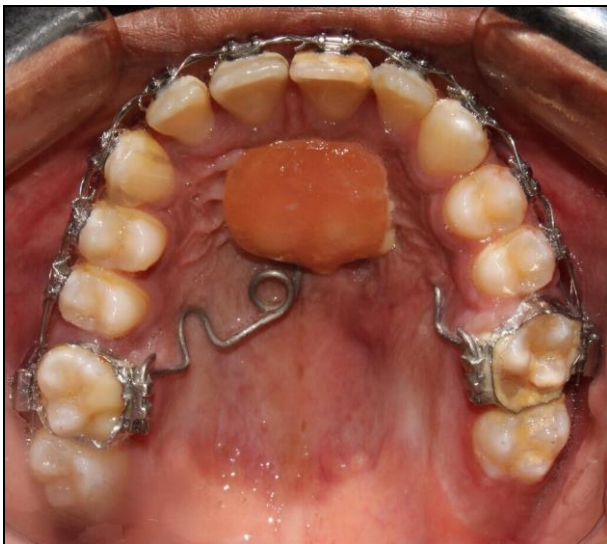
During the follow-up visit, mucosal entrapment of the palatal appliance was observed (figure 2). An intraoral inspection revealed that the wire component of the appliance on the left side was embedded in the hard palatal mucosa. The mucosal cover did not show any signs of inflammation or bleeding. The affected area was non-tender upon palpation. The clinical findings suggested that the overlying soft tissue was non-inflammatory and occurred due to forceful impingement of wire component on the palatal mucosa.

**Fig 2:** Partial palatal soft tissue entrapment of orthodontic appliance

In the present case, the mini-implant-supported pendulum appliance was partially encapsulated in the palatal mucosa. Excessive pressure from the wire component on the palatal mucosa for a longer duration resulted in entrapment. The partial entrapment of the wire component and the remaining appliance was clinically evident and could be located intraorally; hence, radiographic investigations were not required. The appliance was surgically removed with minimal soft tissue trauma. Complete removal of the appliance was confirmed by evaluating all components of the appliance retrieved from the affected site.

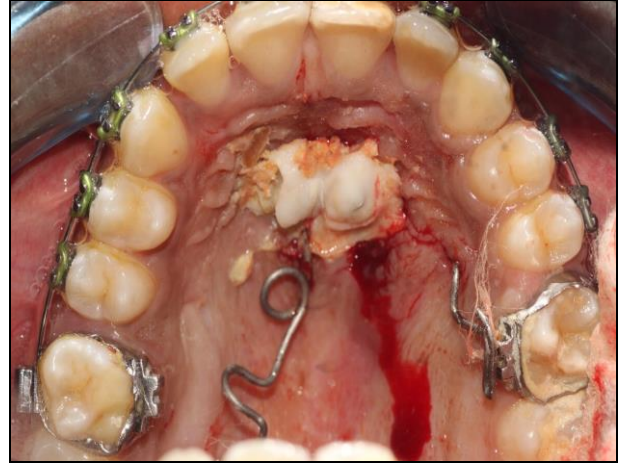
**Fig 3:** Removal of acrylic button to access mini-implants

A pre-surgical mouth rinse with 10 ml 0.2% chlorhexidine gluconate solution was performed for 1 min. Local anesthesia was induced in the palate using a greater palatine and incisive nerve block with 2% lignocaine with a 1:200,000 concentration of adrenaline. The acrylic palatal button covering the mini-implant was removed (figure 3), and the underlying food debris and composite resin material were cleaned, followed by removal of the mini-implants using implant driver as adequate molar distalization was achieved (figure 4). Soft-tissue probing was performed to locate the metallic component of the appliance in the palatal tissue to minimize soft-tissue injury. The distal end of the wire was disengaged, the helix was traced, and a V-shaped incision was made to expose the wire. Using a wire cutter, the helix component was cut on the mesial side and removed from the tissue. The remaining wire was traced in a similar manner and removed from the palatal tissue with a minimal incision. For primary closure, silk sutures were placed which were

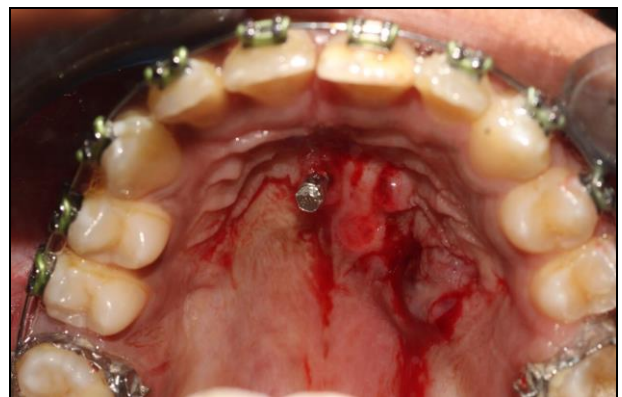
**Fig 4:** Removal of wire component and left mini-implant

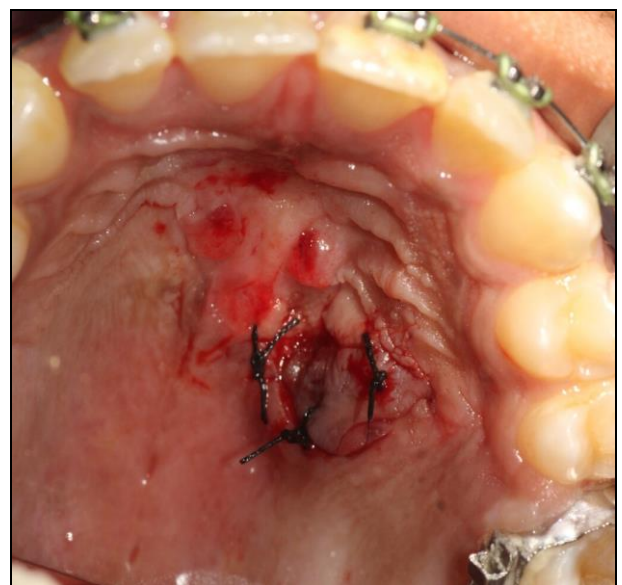
**Fig 5:** Sutures placed

removed a week later (figure 5). All the removed components of the appliances were assessed to eliminate the possibility of entrapping the remaining parts (figure 6). Postoperative instructions were given, and the patient was prescribed antibiotic Amoxicillin 500 mg thrice daily for 3 days and analgesic Aceclofenac (100 mg) and paracetamol (500 mg) combination, twice daily for 3 days. Betadine mouth rinse was prescribed twice daily for one week. Healing was uneventful, with minimal discomfort (figure 7).

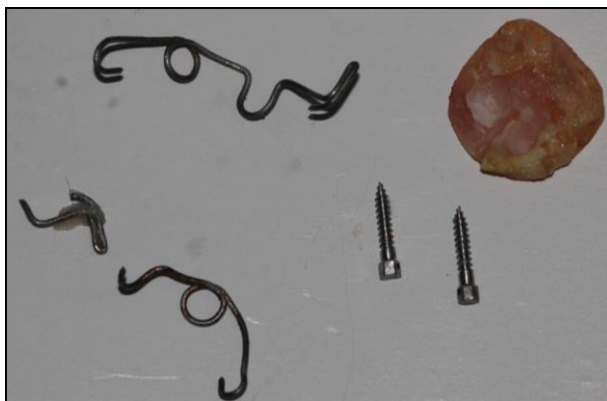
**Fig 6:** All the components of removed orthodontic appliance

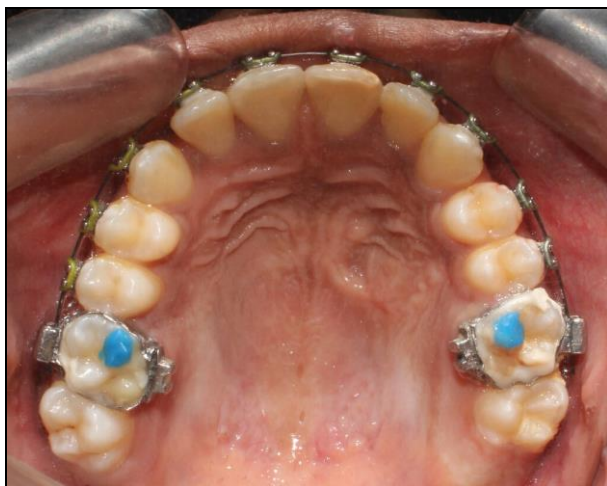
**Fig 7:** Post-operative healing
